Attachment 4
Photograph Log

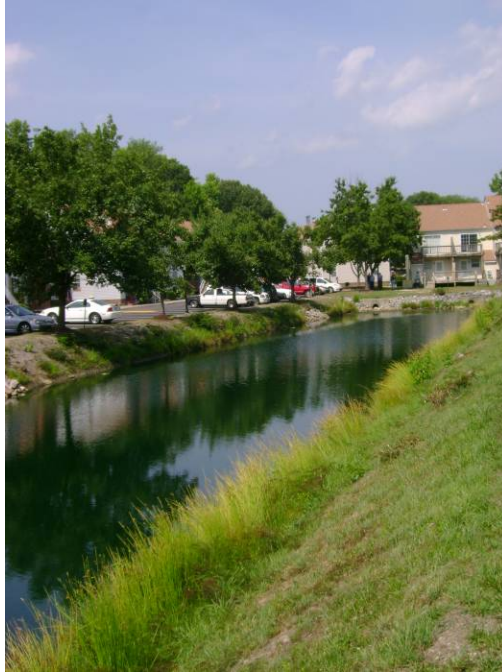
Photograph 5. Francisco Condominium Association A – Overview of stormwater management pond (facing east-northeast).

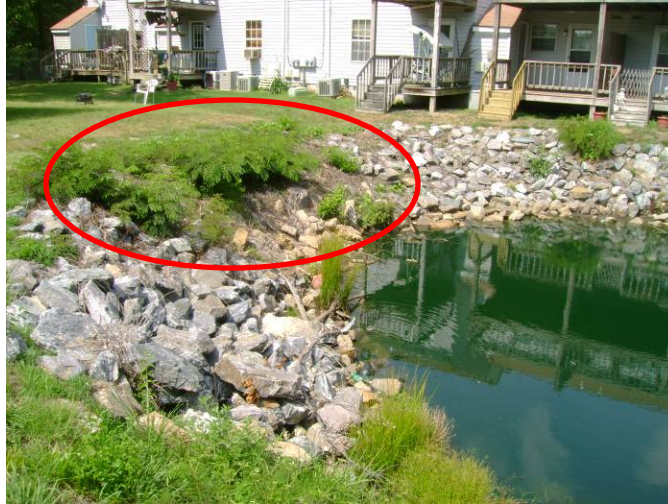
Photograph 9. Francisco Condominium Association A – Erosion evident on side slope in alcove on west portion of the pond.

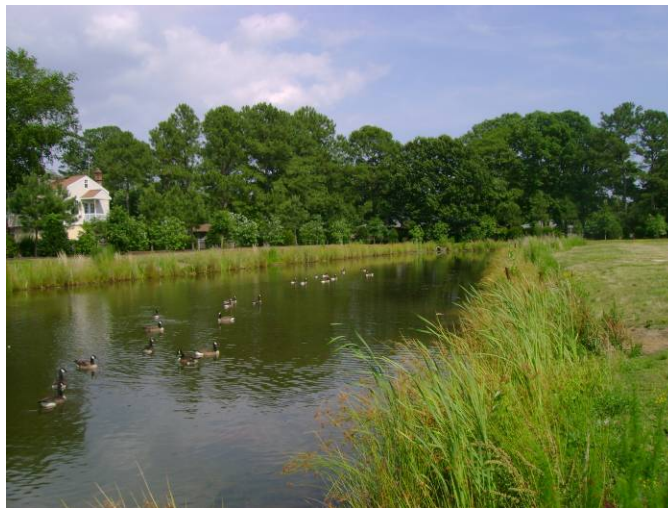
Photograph 10. Police Headquarters – Overview of stormwater management pond (facing southeast).

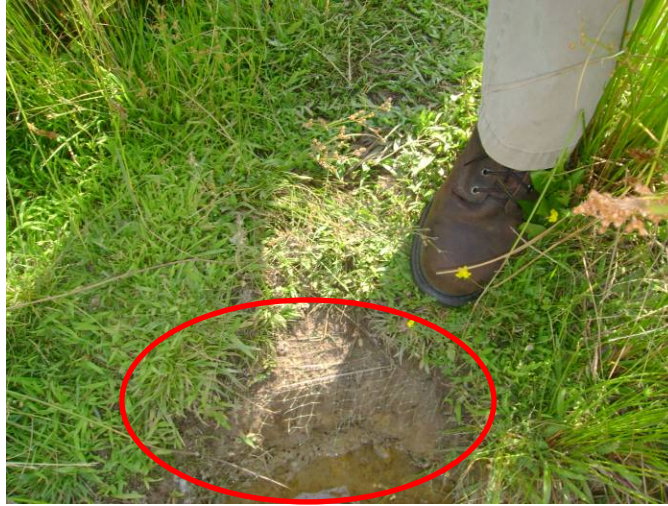
Photograph 11. Police Headquarters – Example of erosion on the bank of the stormwater management pond. Note existing netting from vegetation netting presumably installed during construction of the facility several years prior to the inspection.

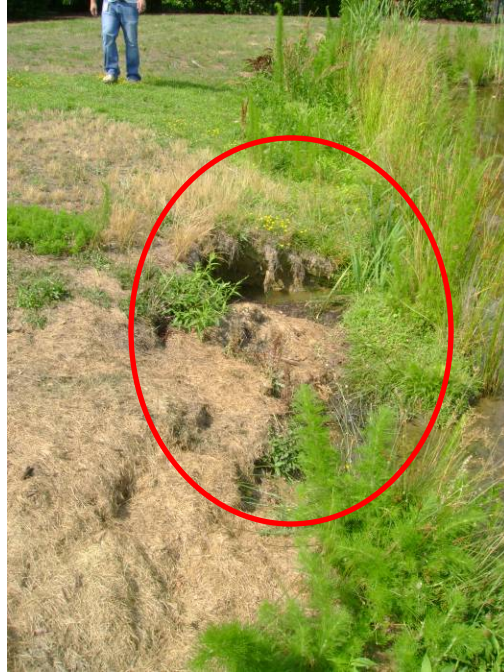
Photograph 13. Police Headquarters – Another example of erosion on the bank of the stormwater management pond.

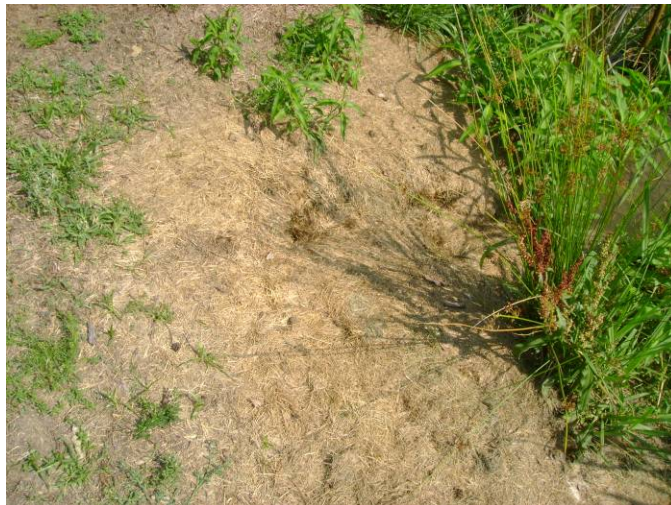
Photograph 14. Police Headquarters – Dead grass and slowly eroding side slope along the bank of the stormwater management pond.

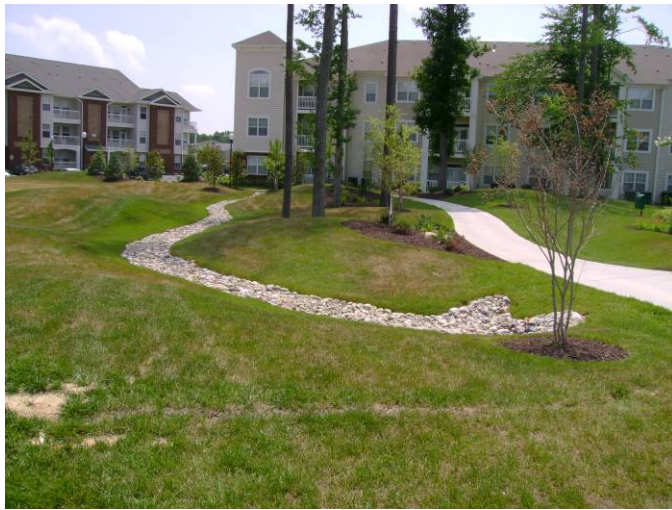
Photograph 18. Windy Knolls – Rock swale running through the middle of the development near the pool.

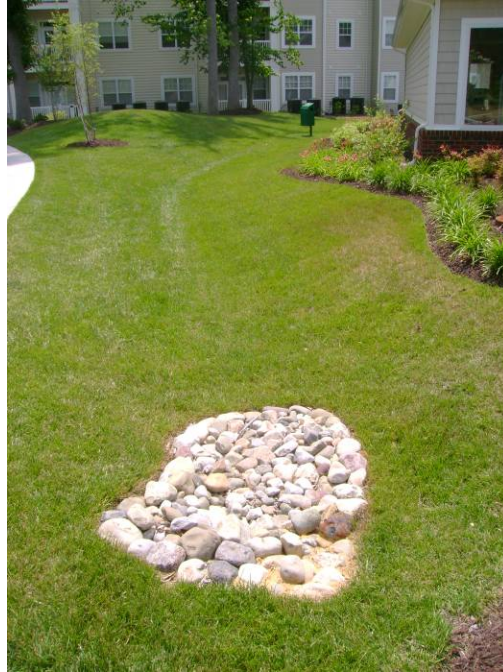
Photograph 19. Windy Knolls – Vegetated and rock swale running through community.

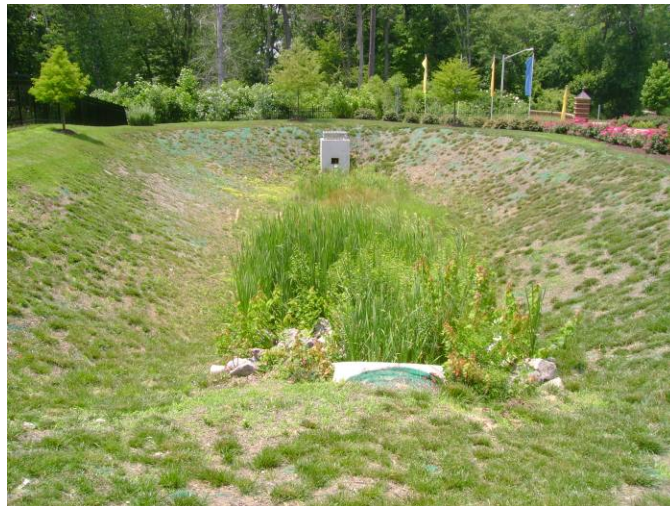
Photograph 20. Windy Knolls – View of stormwater management pond near the entrance to the community. Note stressed vegetation in dry pond.

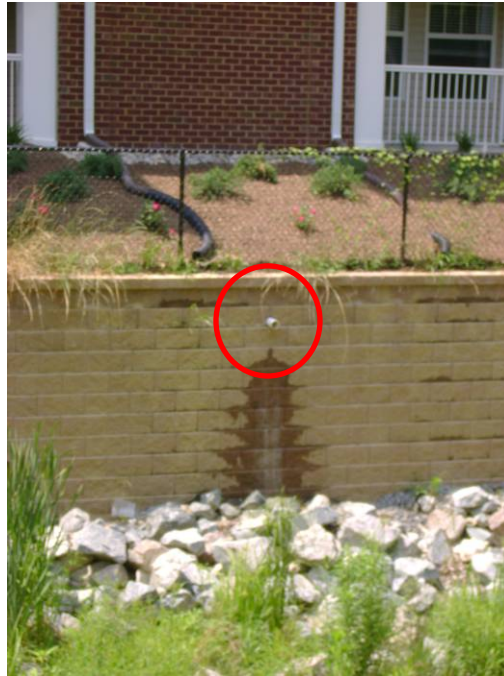
Photograph 26. Windy Knolls – Retaining wall seep hole and black corrugated pipe (used to direct water from the roof) discharging to a delineated wetland in the back of the community near Buildings 5 and 6 on site plans.

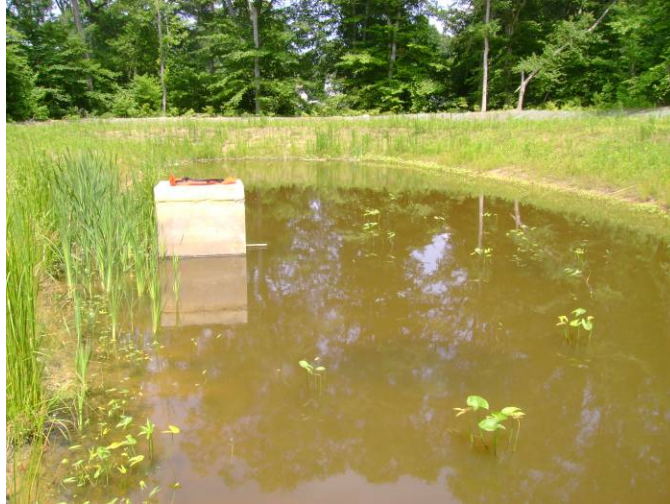
Photograph 27. Windy Knolls – Overview of stormwater management pond located in the back of the community near Buildings 5 and 6 on site plans.

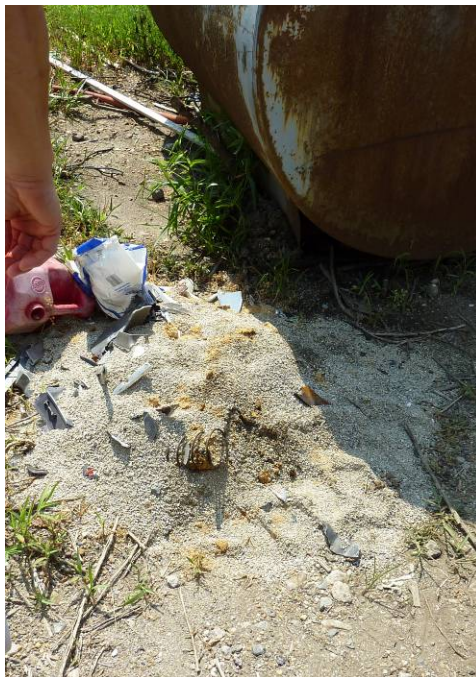
Photograph 28. Pete's Used Auto Parts – Pile of oil drying material, trash and debris left outside

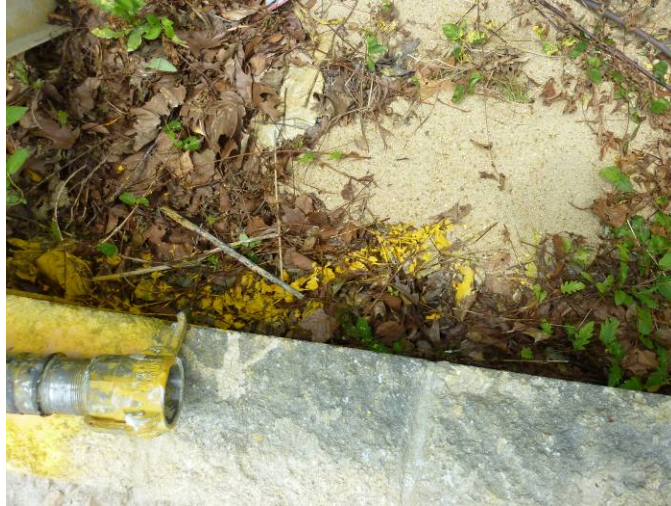
Photograph 74. City Traffic Operations Facility – Paint spill on vegetation outside of curb

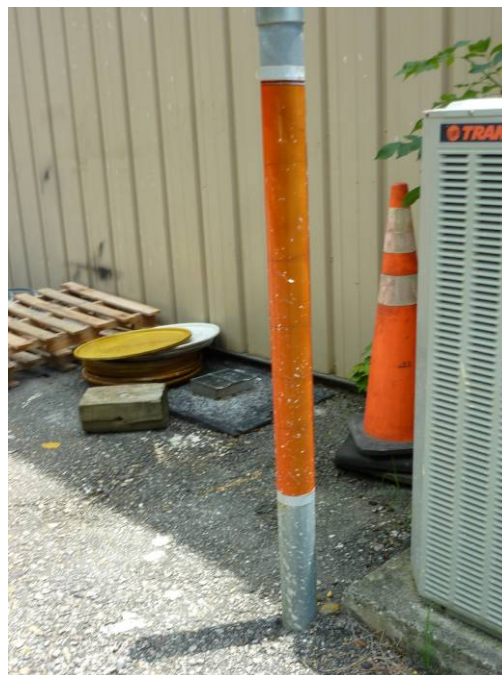
Photograph 75. City Traffic Operations Facility – Paint spray outside

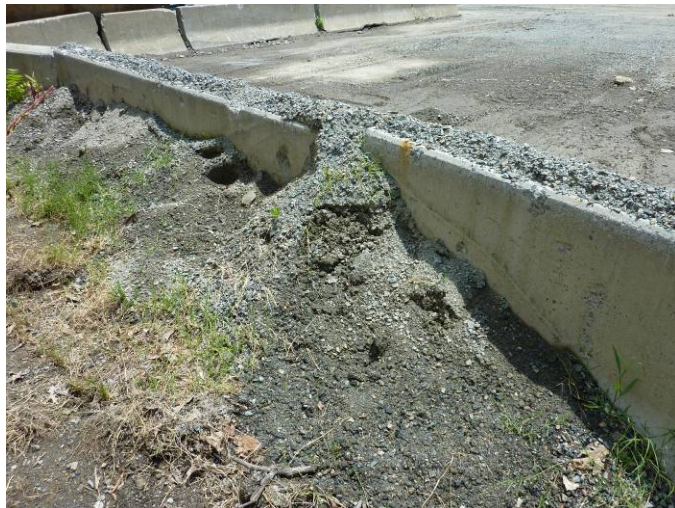
Photograph 79. City Stockpile Area – Gravel spilled through and accumulated behind concrete barriers

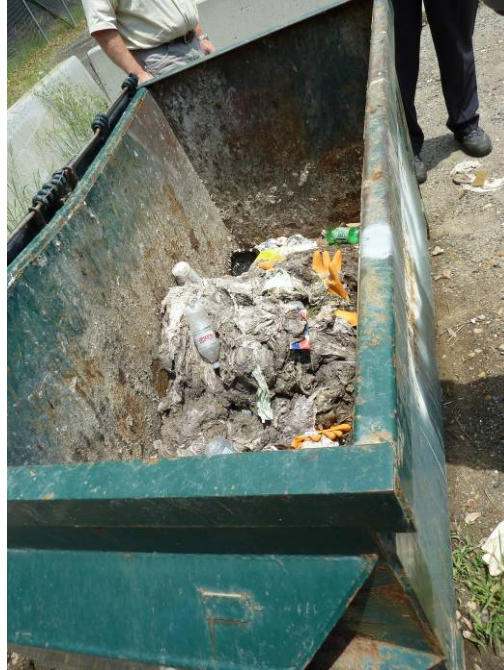
Photograph 80. City Stockpile Area – Open dumpster containing trash located outside

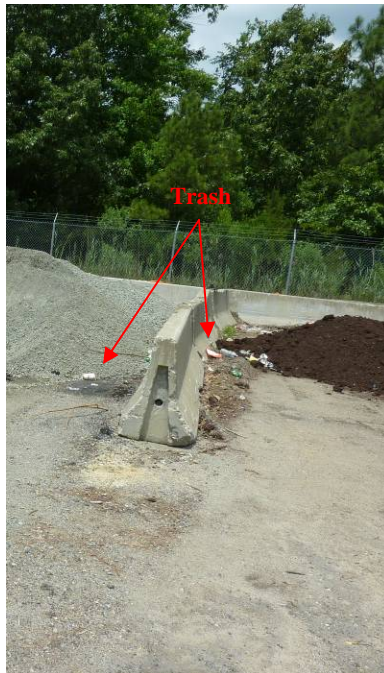
Photograph 81. City Stockpile Area – Trash strewn near stockpiles
